**Flood Control Project Maintenance
Levee Inspections**

Maintenance Issue Types Only, Levee Inspection Report By Mile - Spring 2018

Reclamation District No. 2058 Pescadero

Waterway	Bank	Unit Miles	Inspection Start/End	Inspector
Unit No. 01 Paradise Cut	Left	6.58	03/12/2018 03/12/2018	Maksim Khashchuk

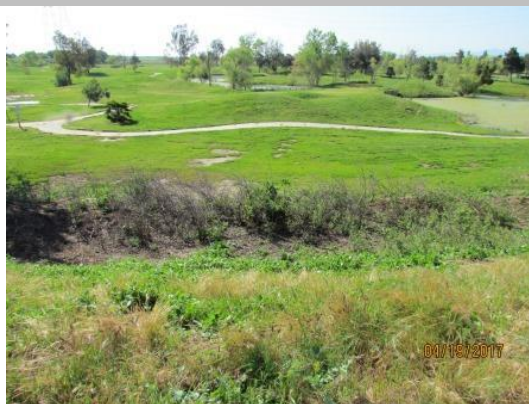
Photo 1 of 1 : SP_2018_RD2058_111_4_20180305_00005.jpg

LM Start	0.23	Rating **	M	Issue No.	4
LM End	0.23	Issue Type +	Ma	Location *	LS
Category	Earthen Levee			GPS Latitude/Longitude	
				Start	End
Item	Vegetation			37.804351 °	37.804351 °
				-121.418433 °	-121.418433 °
DWR ID	DWR_RD2058_01_f_2013_4				
Comment Code					
V2 : Remove the wild growth other than native grasses from the levee slopes.					
Inspector Comment					
Wild rose on the levee. This area is riparian rabbit habitat.

View of the wild rose on the levee slope obstructing visibility and access.

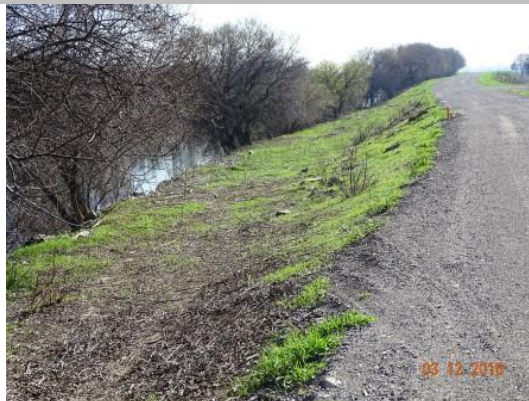
Photo 1 of 1 : SP_2018_RD2058_111_32_20180314_00064.jpg

LM Start	0.37	Rating **	A	Issue No.	32
LM End	2.12	Issue Type +	Ma	Location *	WS
Category	Earthen Levee			GPS Latitude/Longitude	
				Start	End
Item	Vegetation			37.804255 °	37.803859 °
				-121.416302 °	-121.386171 °
DWR ID	DWR_RD2058_01_f_2017_32				
Comment Code					
V1 : Control annual grass and weeds on the levee slopes and easements.					
Inspector Comment					
Acceptable vegetation control on the levee slope.

View of the acceptable vegetation control on the levee slope.

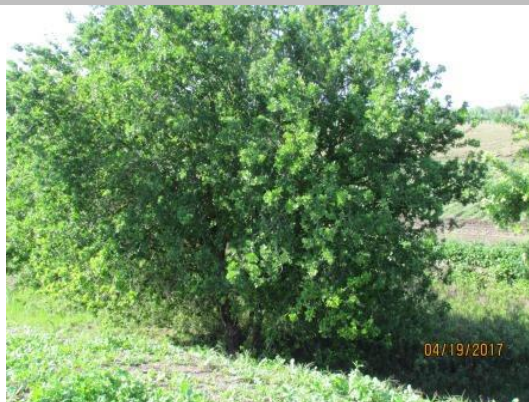
Photo 1 of 1 : SP_2018_RD2058_111_21_20180305_00013.jpg

LM Start	0.55	Rating **	M	Issue No.	21
LM End	0.55	Issue Type +	Ma	Location *	LS
Category	Earthen Levee			GPS Latitude/Longitude	
				Start	End
Item	Trim / Thin Trees			37.802369 °	37.802369 °
				-121.413902 °	-121.413902 °
DWR ID	DWR_RD2058_01_s_2017_21				
Comment Code					
T1 : Trim trees to at least five feet above ground level.					
Inspector Comment

View of the tree that needs to be trimmed.

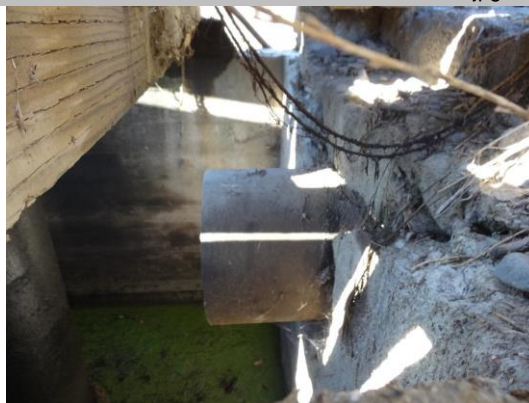
Photo 1 of 1 : UCIP_SP_2018_45143_45168.jpg

Comment Code						
Inspector Comment						
FS_ID:45143 DS_ID:22704 EP_NO: N/A Repair Type: No Action Needed Crossing Status: Found UCIP Comments: FIELD_STRUCT_DESC: *ABANDONED* 12-inch drainage discharge pipe of an unknown material through the levee, 18 feet below the crown. Pump on the landside (LS). Flap gate on the waterside (WS). (To abandon the existing 12-inch pipe with concrete and install a new 16-inch pipe authorized under Permit No. 5055, 1965 - Stanley Electric Motor Company). 12-inch pipe grouted in place. [Additional Reference(s): DWR Levee Log, 2005. USACE San Joaquin O&M Manual 10, March 1964, (HLM 0.72)]. FS Date: 5/12/2015

LS view: an abandoned pipe found in concrete sump.

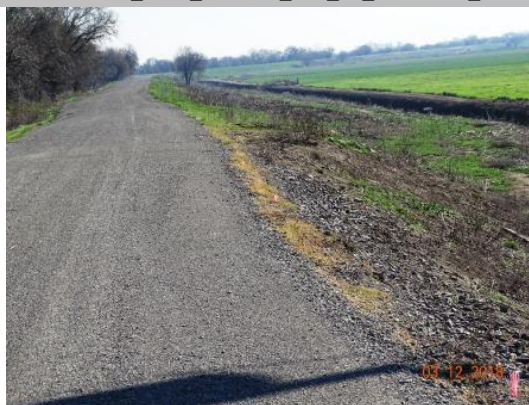
Photo 1 of 1 : SP_2018_RD2058_111_35_20180314_00065.jpg

LM Start	0.75	Rating **	A	Issue No.	35
LM End	2.12	Issue Type +	Ma	Location *	LS
Category	Earthen Levee			GPS Latitude/Longitude	
				Start	End
Item	Vegetation			37.801742 °	37.803859 °
				-121.410323 °	-121.386171 °
DWR ID	DWR_RD2058_01_f_2017_35				
Comment Code					
V1 : Control annual grass and weeds on the levee slopes and easements.					
Inspector Comment					
Acceptable vegetation control on the levee slope.

View of the acceptable vegetation control on the levee slope.

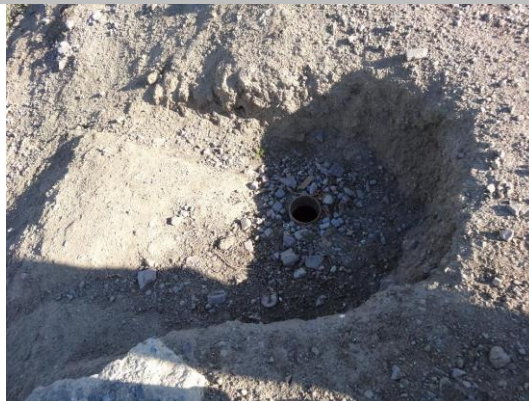
Photo 1 of 3 : UCIP_SP_2018_51161_45171.jpg

FS_ID:51161
DS_ID:22694
EP_NO: 11546
Repair Type: Urgent
Crossing Status: Found
UCIP Comments: 11/29/2016 Heavy erosion still present. Could be due to wave run-up as this is the only spot on levee not rock revetted. Greg Pombo (RD2058) indicated permits for endangered species prevent rock revetment. (K. Fazel - UCIP)05/12/2015 Erosion on west side of pipe at W/S toe. (K. Fazel - UCIP)
FIELD_STRUCT_DESC: 1 of 2: 18-inch steel drainage discharge pipe through the levee, 2 feet below the crown. Pump in drainage ditch on the landside (LS). Siphon breaker with cover on the waterside (WS) shoulder. Electrical service pole at the LS toe. (18-inch pipe and pump authorized under Permit No. 11546, 1976 - Reclamation District No. 2058). [Additional Reference(s): DWR Levee Log, 2005].
FS Date: 11/29/2016

WS view: siphon breaker hole. Siphon breaker removed for repair.

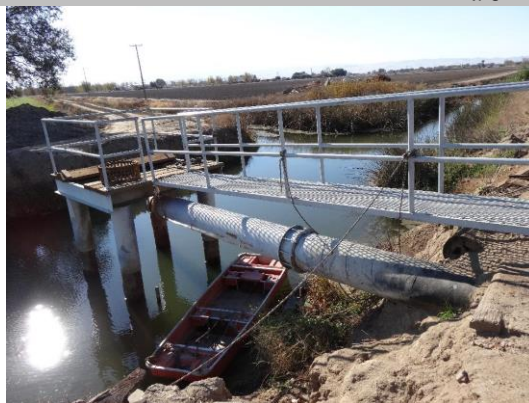
Photo 2 of 3 : UCIP_SP_2018_51161_45170.jpg

LS view: pipe, pile structure, and pump platform in drain ditch.

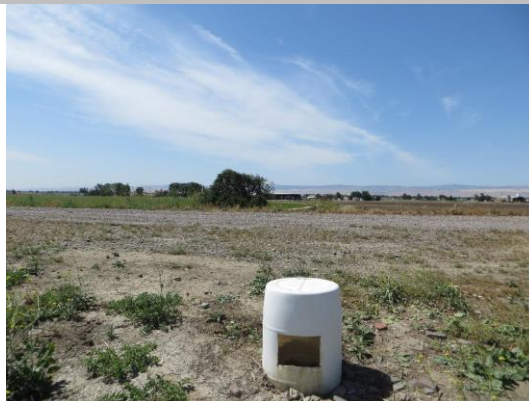
Photo 1 of 3 : UCIP_SP_2018_45865_74323.jpg

LM Start	2.12	Rating **	A/W	Issue No.	979
LM End	2.12	Issue Type +	Ma	Location *	
Category	Supplemental			GPS Latitude/Longitude	
				Start	End
Item	DWR UCIP LMA Responsibility			37.803892 °	37.803892 °
				-121.386299 °	-121.386299 °
DWR ID					
Comment Code					
Inspector Comment					
FS_ID:45865 DS_ID:22705 EP_NO: N/A Repair Type: No Action Needed Crossing Status: Found UCIP Comments: FIELD_STRUCT_DESC: 20-inch steel drainage discharge pipe through the levee, 8 feet below the crown. Pump on a concrete sump in a drainage ditch on the landside (LS) toe. Siphon breaker on the waterside (WS) shoulder. [Additional Reference(s): USACE San Joaquin O&M Manual 10, March 1964, (HLM 2.14), 18-inch pipe referenced]. FS Date: 5/12/2015

Siphon breaker on WS shoulder inside protective riser.

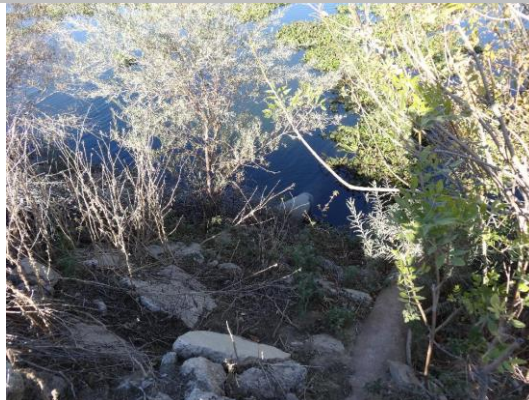
Photo 2 of 3 : UCIP_SP_2018_45865_74324.jpg

Pipe just visible at WS toe at center of photograph.

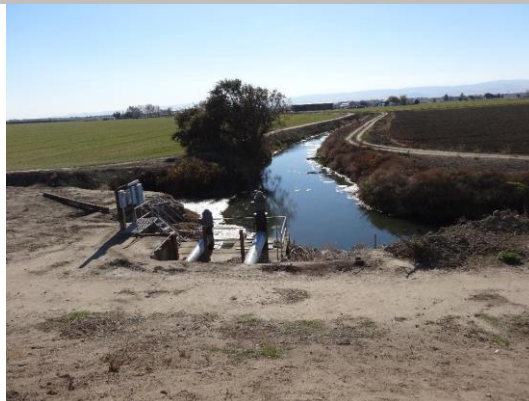
Photo 3 of 3 : UCIP_SP_2018_45865_74325.jpg

LM Start	2.12	Rating **	A/W	Issue No.	979 (cont)
LM End	2.12	Issue Type +	Ma	Location *	
Category	Supplemental			GPS Latitude/Longitude	
				Start	End
Item	DWR UCIP LMA Responsibility			37.803892 °	37.803892 °
				-121.386299 °	-121.386299 °
DWR ID					
Comment Code					
Inspector Comment					
FS_ID:45865 DS_ID:22705 EP_NO: N/A Repair Type: No Action Needed Crossing Status: Found UCIP Comments: FIELD_STRUCT_DESC: 20-inch steel drainage discharge pipe through the levee, 8 feet below the crown. Pump on a concrete sump in a drainage ditch on the landside (LS) toe. Siphon breaker on the waterside (WS) shoulder. [Additional Reference(s): USACE San Joaquin O&M Manual 10, March 1964, (HLM 2.14), 18-inch pipe referenced]. FS Date: 5/12/2015

Pump on concrete pad at LS toe.

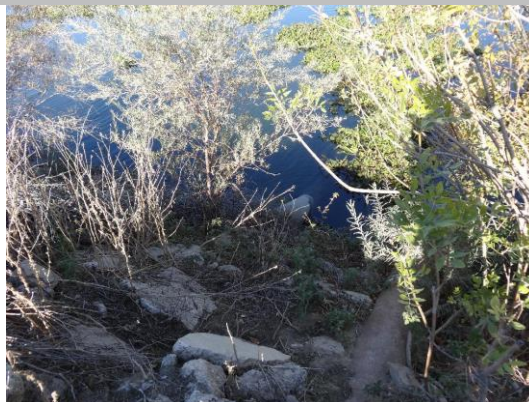
Photo 1 of 3 : UCIP_SP_2018_51699_45192.jpg

LM Start	2.12	Rating **	M	Issue No.	980
LM End	2.12	Issue Type +	Ma	Location *	
Category	Supplemental			GPS Latitude/Longitude	
				Start	End
Item	DWR UCIP LMA Responsibility			37.803886 °	37.803886 °
				-121.386271 °	-121.386271 °
DWR ID					
Comment Code					
Inspector Comment					
FS_ID:51699 DS_ID:22706 EP_NO: N/A Repair Type: Non-Urgent Crossing Status: Found UCIP Comments: Leaky and damaged siphon breaker on waterside shoulder.. FIELD_STRUCT_DESC: 16-inch steel drainage discharge pipe through the levee, 8 feet below the crown. Pump on a concrete sump in a drainage ditch on the landside (LS) toe. Siphon breaker on the waterside (WS) shoulder. [Additional Reference(s): USACE San Joaquin O&M Manual 10, March 1964, (HLM 2.14), 12-inch pipe referenced]. FS Date: 5/13/2015

WS view: exposed steel pipe (right) on channel bank.

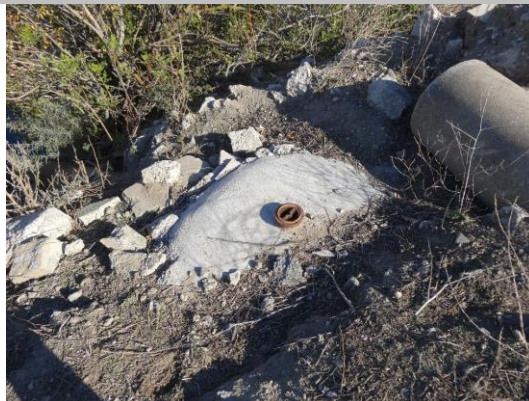
Photo 2 of 3 : UCIP_SP_2018_51699_45191.jpg

LM Start	2.12	Rating **	M	Issue No.	980 (cont)	
LM End	2.12	Issue Type +	Ma	Location *		
Category	Supplemental			GPS Latitude/Longitude		
				Start		End
Item	DWR UCIP LMA Responsibility			37.803886 °	37.803886 °	
				-121.386271 °	-121.386271 °	
DWR ID						
Comment Code						
Inspector Comment						
FS_ID:51699						
DS_ID:22706						
EP_NO: N/A						
Repair Type: Non-Urgent						
Crossing Status: Found						
UCIP Comments: Leaky and damaged siphon breaker on waterside shoulder..						
FIELD_STRUCT_DESC: 16-inch steel drainage discharge pipe through the levee, 8 feet below the crown. Pump on a concrete sump in a drainage ditch on the landside (LS) toe. Siphon breaker on the waterside (WS) shoulder. [Additional Reference(s): USACE San Joaquin O&M Manual 10, March 1964, (HLM 2.14), 12-inch pipe referenced].						
FS Date: 5/13/2015

WS view: siphon breaker on concrete pad on levee slope.

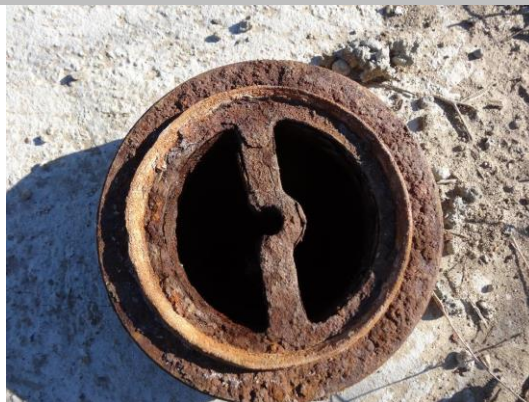
Photo 3 of 3 : UCIP_SP_2018_51699_45190.jpg

WS view: Upper part of the siphon breaker missing.

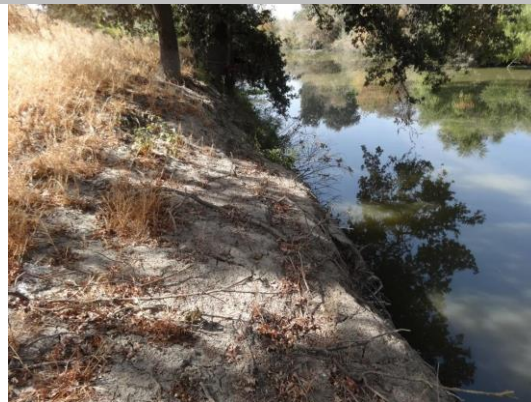
Photo 1 of 4 : SP_2018_RD2058_111_1_20180305_00001.jpg

Comment Code					
Inspector Comment					
10/10/2017: No significant change observed.					
07/20/2016: No significant change observed.					
08/04/2015: No significant change observed.					
08/26/2014: No significant change observed.					
08/28/2013: No significant change observed.					
07/26/2012: The site has been visited, and no significant change has been observed.					
09/02/2011: This site was not visited due to the time limit.					
09/22/2010: No significant change observed. Minor pocket erosions are lined at the lower bank. Two large Oak and Willow trees are on mid-slope and bench. The remaining bench was re-measured and found to be approximately 10 feet. There was no indication of active erosion on site during the site visit.					
08/05/2010: Recommended for annual assessment and monitoring of the site during flood events, per CLRO.					
07/23/2009: No major change observed since last visit; site is a 200-ft. long near-vertical berm erosion; recommend annual assessment and monitoring of the erosion site, per CLRO CES Evaluation 2008 Report; Site # is the same site previously reported as RM4.0,LM4.51; previously rated "U".

09/10/2008: Two large trees (2-3' DBH) with partial roots exposed.					
2007: Visited site 03/13/2007. [2017 Site ID:RD2058U01RM3.97]

Direct view of the pocket erosion site.

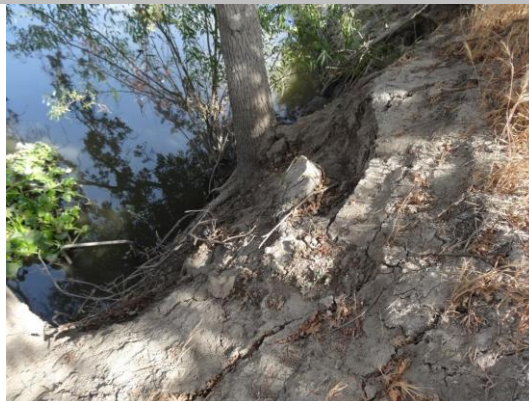
Photo 2 of 4 : SP_2018_RD2058_111_1_20180305_00002.jpg

10/10/2017: No significant change observed.
 07/20/2016: No significant change observed.
 08/04/2015: No significant change observed.
 08/26/2014: No significant change observed.
 08/28/2013: No significant change observed.
 07/26/2012: The site has been visited, and no significant change has been observed.
 09/02/2011: This site was not visited due to the time limit.
 09/22/2010: No significant change observed. Minor pocket erosions are lined at the lower bank. Two large Oak and Willow trees are on mid-slope and bench. The remaining bench was re-measured and found to be approximately 10 feet. There was no indication of active erosion on site during the site visit.
 08/05/2010: Recommended for annual assessment and monitoring of the site during flood events, per CLRO.
 07/23/2009: No major change observed since last visit; site is a 200-ft. long near-vertical berm erosion; recommend annual assessment and monitoring of the erosion site, per CLRO CES Evaluation 2008 Report; Site # is the same site previously reported as RM4.0, LM4.51; previously rated "U".

Direct view of the erosion near a tree.

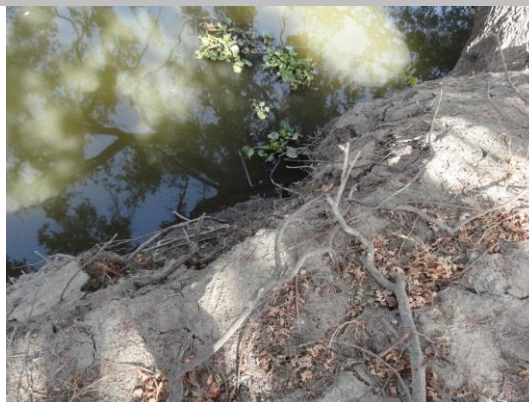
Photo 3 of 4 : SP_2018_RD2058_111_1_20180305_00003.jpg

Close view of the erosion.

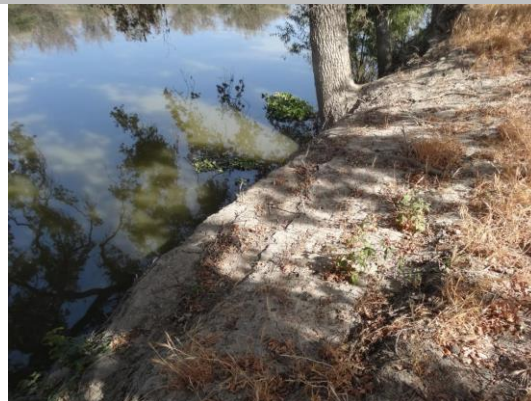
Photo 4 of 4 : SP_2018_RD2058_111_1_20180305_00004.jpg

Comment Code					
Inspector Comment					
10/10/2017: No significant change observed.					
07/20/2016: No significant change observed.					
08/04/2015: No significant change observed.					
08/26/2014: No significant change observed.					
08/28/2013: No significant change observed.					
07/26/2012: The site has been visited, and no significant change has been observed.					
09/02/2011: This site was not visited due to the time limit.					
09/22/2010: No significant change observed. Minor pocket erosions are lined at the lower bank. Two large Oak and Willow trees are on mid-slope and bench. The remaining bench was re-measured and found to be approximately 10 feet. There was no indication of active erosion on site during the site visit.					
08/05/2010: Recommended for annual assessment and monitoring of the site during flood events, per CLRO.					
07/23/2009: No major change observed since last visit; site is a 200-ft. long near-vertical berm erosion; recommend annual assessment and monitoring of the erosion site, per CLRO CES Evaluation 2008 Report; Site # is the same site previously reported as RM4.0,LM4.51; previously rated "U".

09/10/2008: Two large trees (2-3' DBH) with partial roots exposed.					
2007: Visited site 03/13/2007. [2017 Site ID:RD2058U01RM3.97]

Direct view of the erosion near a tree.

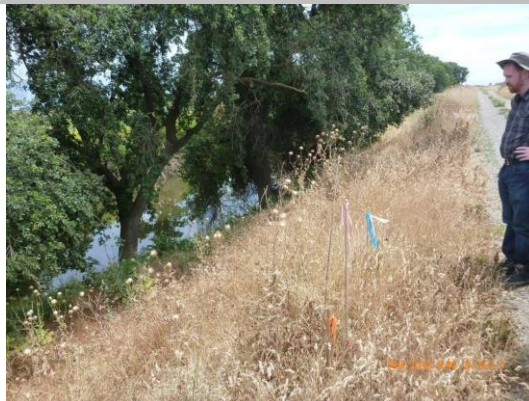
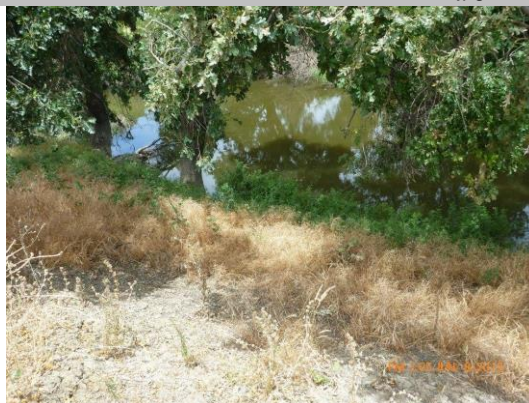
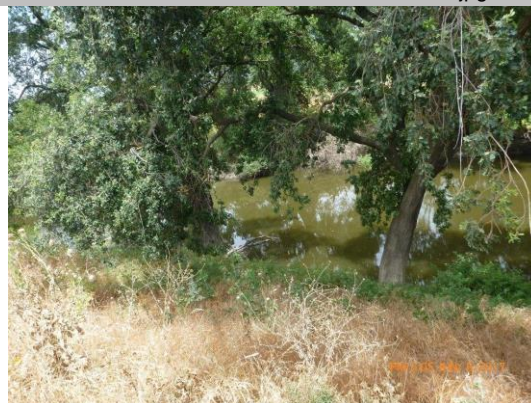
LM Start	4.63	Rating **	A/W	Issue No.	43
LM End		Issue Type +	Ma	Location *	
Category	Supplemental		GPS Latitude/Longitude		
			Start	End	
Item	2017 Storm Damage		37.787800 °	°	
			-121.350860 °	°

Repair Type: Erosion

Notes: vegetation too dense to evaluate damage. Erosion on the waterside is greater than three feet tall into the levee prism as of Fall 2017 Inspection. Turned back over to Evaluators for re-assessment.

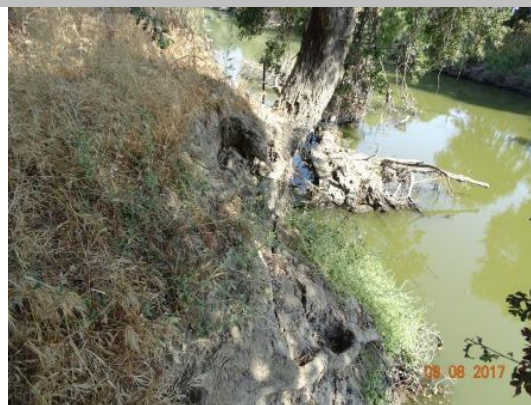
Photo 1 of 5 : SP_2018_RD2058_111_40_20180305_00030.jpg

LM Start	4.63	Rating **	A/W	Issue No.	40
LM End	4.76	Issue Type +	Ma	Location *	WS
Category	Earthen Levee			GPS Latitude/Longitude	
				Start	End
Item	Erosion / Bank Caving			37.787756 °	37.785971 °
				-121.350851 °	-121.350372 °
DWR ID	DWR_RD2058_01_f_2017_40				
Comment Code					
E2 : Schedule repair of erosion site prior to the next inspection.					
Inspector Comment					
Erosion on the waterside is greater than three feet tall into the levee prism.

Downstream view of the erosion.

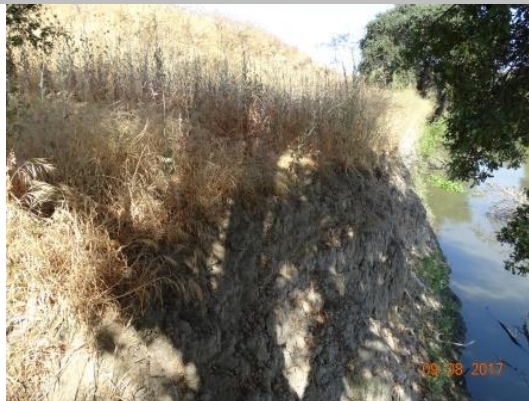
Photo 2 of 5 : SP_2018_RD2058_111_40_20180305_00031.jpg

LM Start	4.63	Rating **	A/W	Issue No.	40 (cont)	
LM End	4.76	Issue Type +	Ma	Location *	WS	
Category	Earthen Levee			GPS Latitude/Longitude		
				Start	End	
Item	Erosion / Bank Caving			37.787756 °	37.785971 °	
				-121.350851 °	-121.350372 °	
DWR ID	DWR_RD2058_01_f_2017_40					
Comment Code						
E2 : Schedule repair of erosion site prior to the next inspection.						
Inspector Comment						
Erosion on the waterside is greater than three feet tall into the levee prism.

Another downstream view of the erosion.

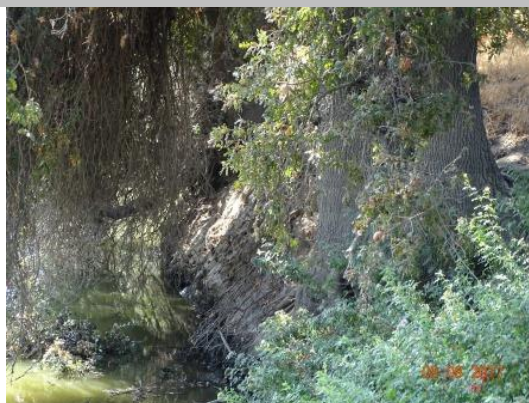
Photo 3 of 5 : SP_2018_RD2058_111_40_20180305_00032.jpg

Upstream view of the erosion site.

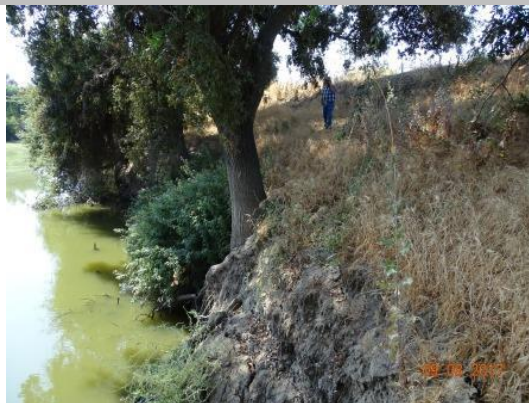
Photo 4 of 5 : SP_2018_RD2058_111_40_20180305_00033.jpg

Another upstream view of the erosion site.

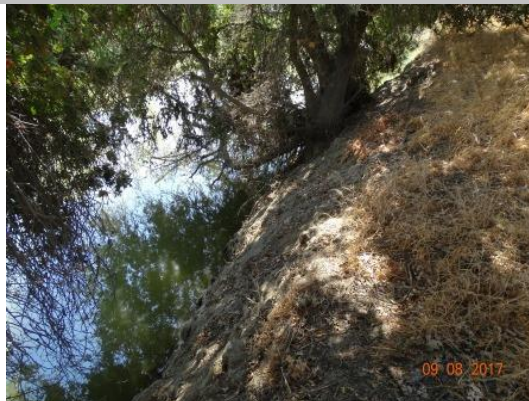
Photo 5 of 5 : SP_2018_RD2058_111_40_20180305_00034.jpg

LM Start	4.63	Rating **	A/W	Issue No.	40 (cont)	
LM End	4.76	Issue Type +	Ma	Location *	WS	
Category	Earthen Levee			GPS Latitude/Longitude		
				Start		End
Item	Erosion / Bank Caving			37.787756 °		37.785971 °
				-121.350851 °		-121.350372 °
DWR ID	DWR_RD2058_01_f_2017_40					
Comment Code						
E2 : Schedule repair of erosion site prior to the next inspection.						
Inspector Comment						
Erosion on the waterside is greater than three feet tall into the levee prism.

Erosion on the bank looking upstream.

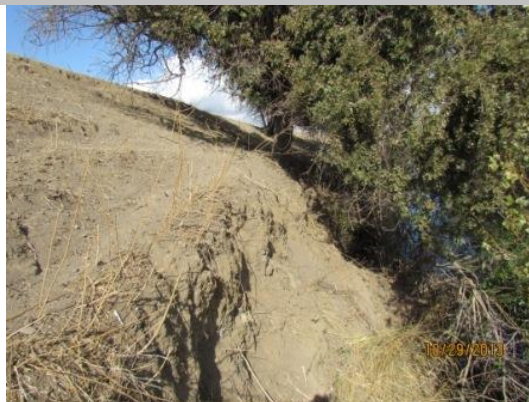
Photo 1 of 3 : SP_2018_RD2058_111_15_20180305_00008.jpg

LM Start	4.76	Rating **	A/W	Issue No.	15
LM End	4.83	Issue Type +	Ma	Location *	WS
Category	Earthen Levee			GPS Latitude/Longitude	
				Start	End
Item	Erosion / Bank Caving			37.785965 °	37.785045 °
				-121.350374 °	-121.349936 °
DWR ID	DWR_RD2058_01_f_2013_15				
Comment Code					
E1 : Note and monitor erosion site.					
Inspector Comment					
The erosion has about a 3 foot vertical cut at the waterside levee toe.

View of the erosion at the waterside levee toe.

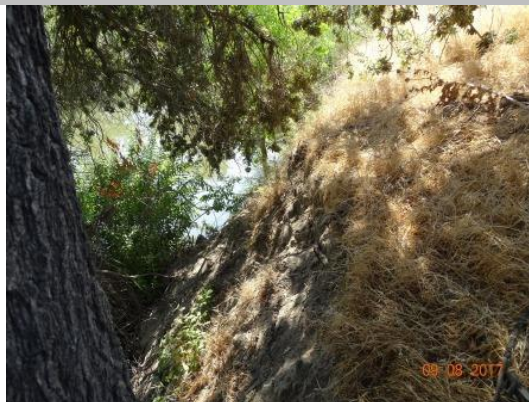
Photo 2 of 3 : SP_2018_RD2058_111_15_20180305_00009.jpg

Upstream view of the erosion.

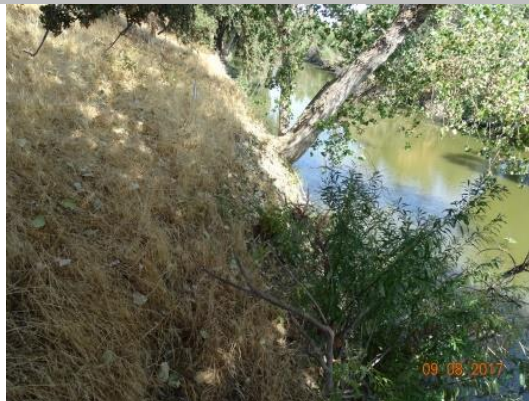
Photo 3 of 3 : SP_2018_RD2058_111_15_20180305_00010.jpg

Downstream view of the erosion site.

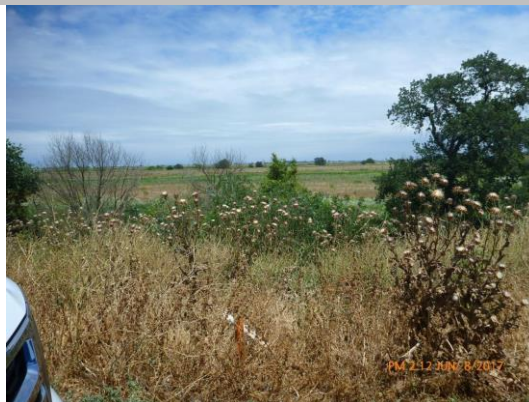
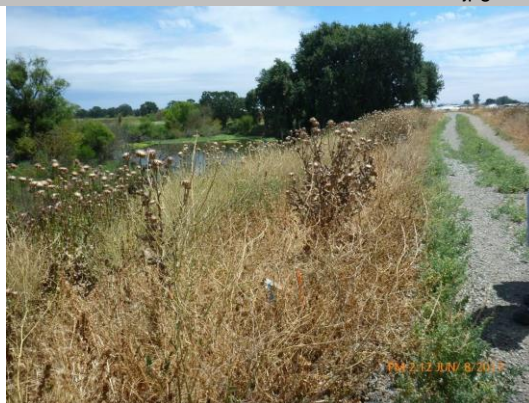
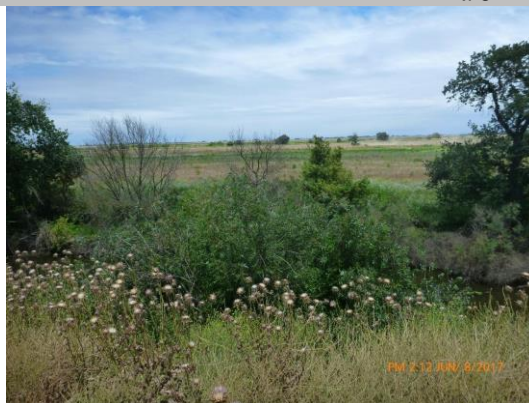
LM Start	4.77	Rating **	A/W	Issue No.	44
LM End		Issue Type +	Ma	Location *	
Category	Supplemental			GPS Latitude/Longitude	
				Start	End
Item	2017 Storm Damage			37.785862 °	°
				-121.350303 °	°
DWR ID	DWR_RD2058_01_f_2017_44				
Comment Code					
Inspector Comment					
Levee Evaluation Comments					
Description:					
Site ID No:100					
Site Designation:FSRP-14-25					
Repair Type: Erosion					
Rating:Area of Concern					
Field Date:6/8/2017					
Notes: vegetation too dense to evaluate damage. The erosion has about a 3 foot vertical cut at the waterside levee toe as of the Fall 2017 Inspection. Turned back over to Evaluators for re-assessment.

Repair Type: Erosion

Notes: vegetation too dense to evaluate damage. The erosion has about a 3 foot vertical cut at the waterside levee toe as of the Fall 2017 Inspection. Turned back over to Evaluators for re-assessment.

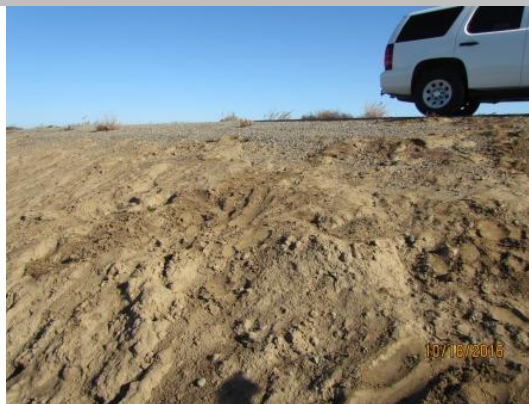
Photo 1 of 1 : SP_2018_RD2058_111_28_20180305_00016.jpg

View of the rodent holes on the levee slope.
